NASA Technical Memorandum 110204

# **Structural Test Documentation and Results for the McDonnell Douglas All-Composite Wing Stub Box**

**Dawn C. Jegley and Harold G. Bush**  
*Langley Research Center, Hampton, Virginia*

**April 1997**

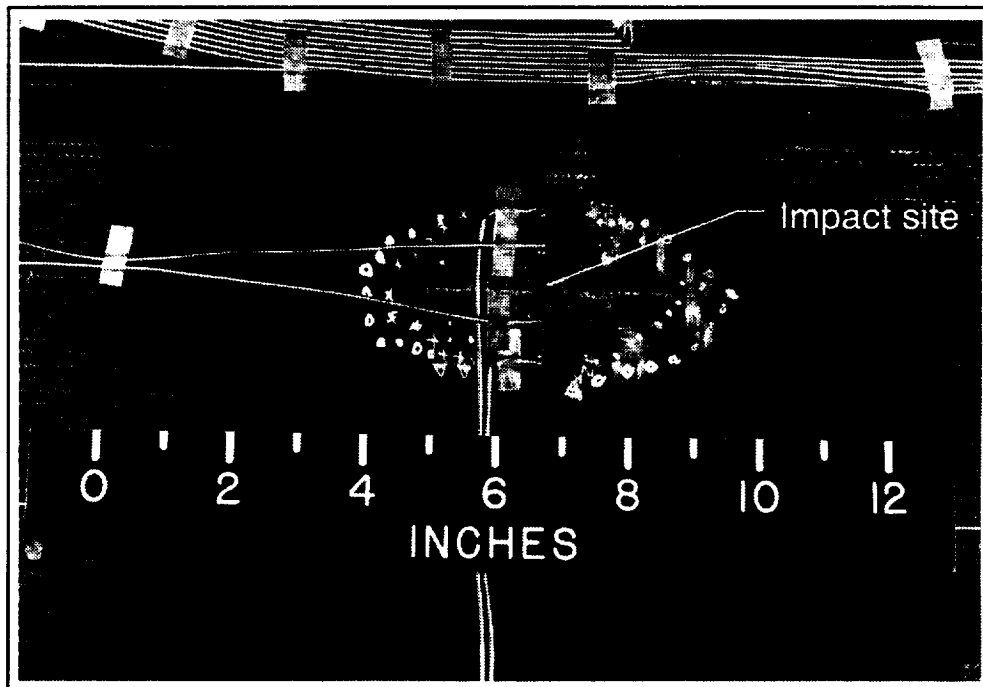
In order to limit the dent depth to 0.1 inches, the damage was inflicted by a series of impacts at the same location. Four impacts were required to inflict the required dent depth. After each impact, the dent depth was measured and the region of skin around the impact site was nondestructively evaluated by ultrasonic scanning to determine the area of the structure which had been damaged. The impact energies of the four impacts and their effects are shown in table 1. After the fourth impact, the dent was 0.093 inches deep and the damage area was defined by an oval with an axial dimension of 5.75 inches and a width dimension of 2.75 inches. No further impacts were made since further growth in the size of the damage area was not desired. The stringer flanges and blades of the upper cover panel were not damaged in the impact process. A photograph of the damaged region, with the region of damage outlined by white marks, is shown in figure 20. Damage was easily visible by eye.

Figure 20. Visible impact damage region DET1.

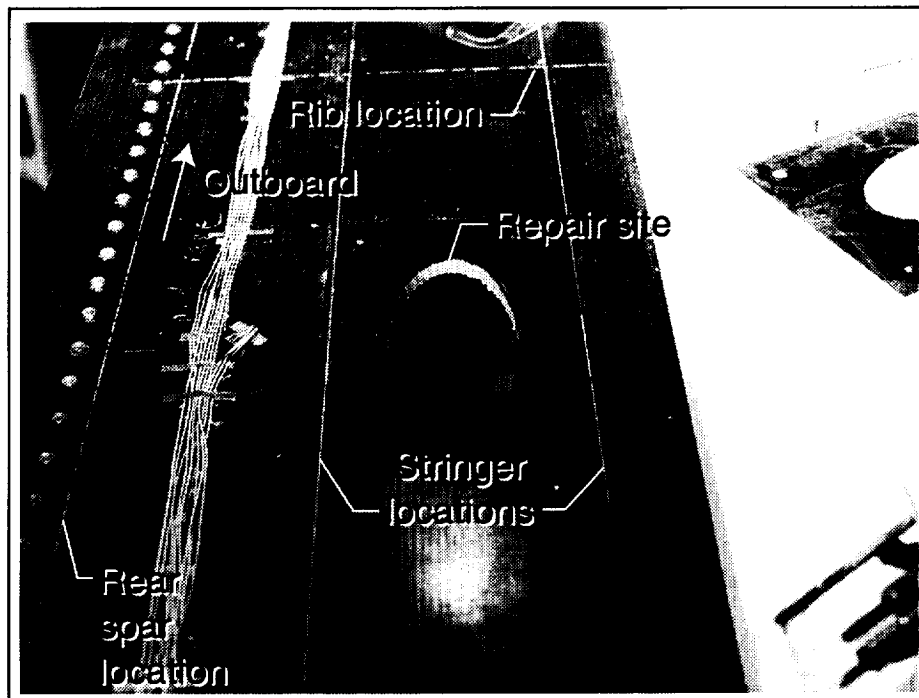
Figure 21. Upper cover panel prior to installation of repair.

A bolt-on metal patch was used to repair the upper cover panel. All materials for the patch were supplied by McDonnell Douglas Aerospace and personnel from American Airlines installed the patch. The structure was prepared for patch installation by cutting out the damaged section of skin, as shown in figure 21. The cutout was in the shape of an ellipse with dimensions 7.5 inches by 3.75 inches. The cutout was in the skin between stringers, as illustrated in figure 22. Bolt holes were drilled through the stringer flanges and skin. A 3/8-inch-thick aluminum plate was bolted to the external skin to cover the cutout. The plate dimensions were 11.7 inches by 7.28 inches. The completed repair is shown in figure 23.

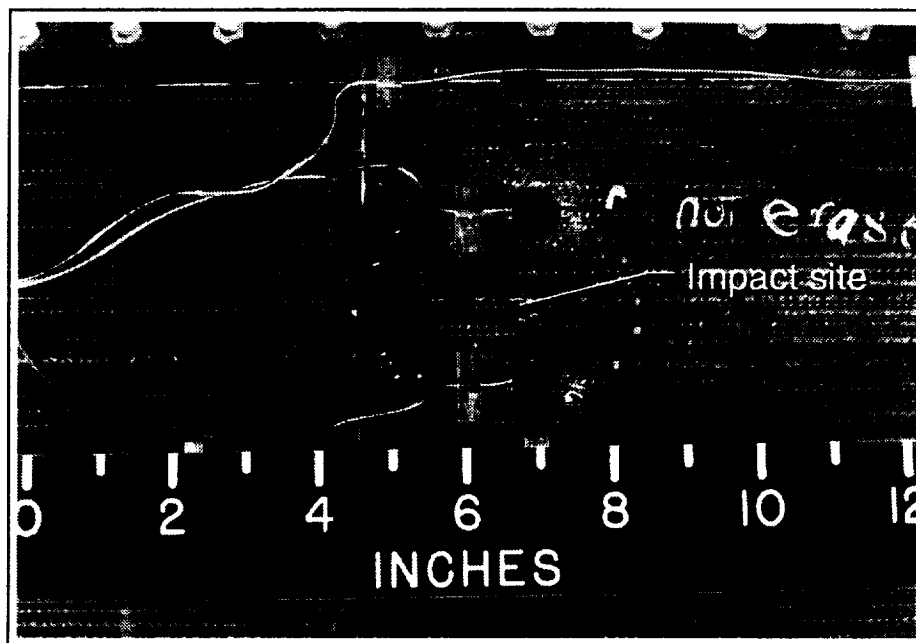
a) Impact region NDT1

A dropped-weight impactor was used to inflict nonvisible damage to the upper cover panel at two locations. An impact energy of 100 ft-lb was used to inflict the nonvisible damage. These impact sites are at a stiffener runout near the front spar and at the edge of a flange near the rear spar. The front and rear impact sites, labeled NDT1 and NDT2, respectively, are shown in figure 5. The damage area in the upper cover panel skin around each damage site was determined ultrasonically and that area was marked on the upper cover panel. Photographs of these damage regions prior to testing are shown in figure 24. The damage area at location NDT1 is an oval with dimensions of 4.0 inches by 3.0 inches. The damage area at location NDT2 is approximately "L" shaped with dimensions of 4.0 inches and 3.0 inches. The dent depth for the dent at location NDT1 is 0.014 inches. The dent depth at location NDT2 is 0.0134 inches.

Figure 24. Nonvisible impact damage sites.

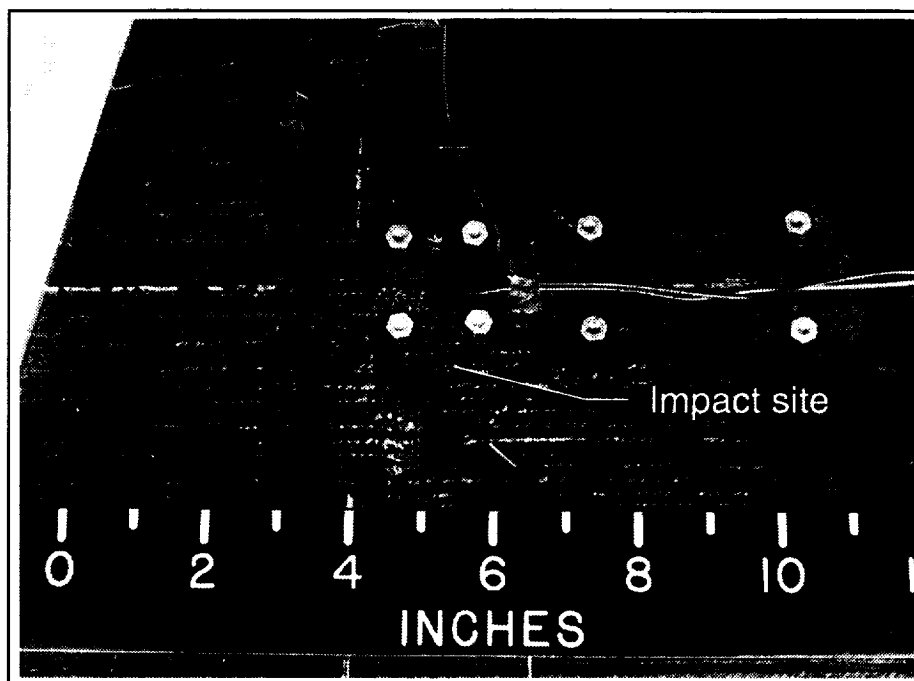
b) Impact region NDT2

Figure 24. Concluded.

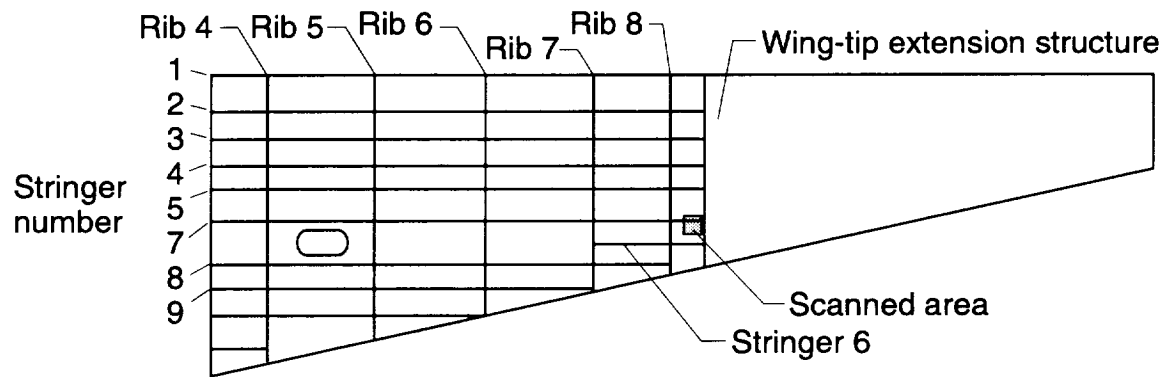
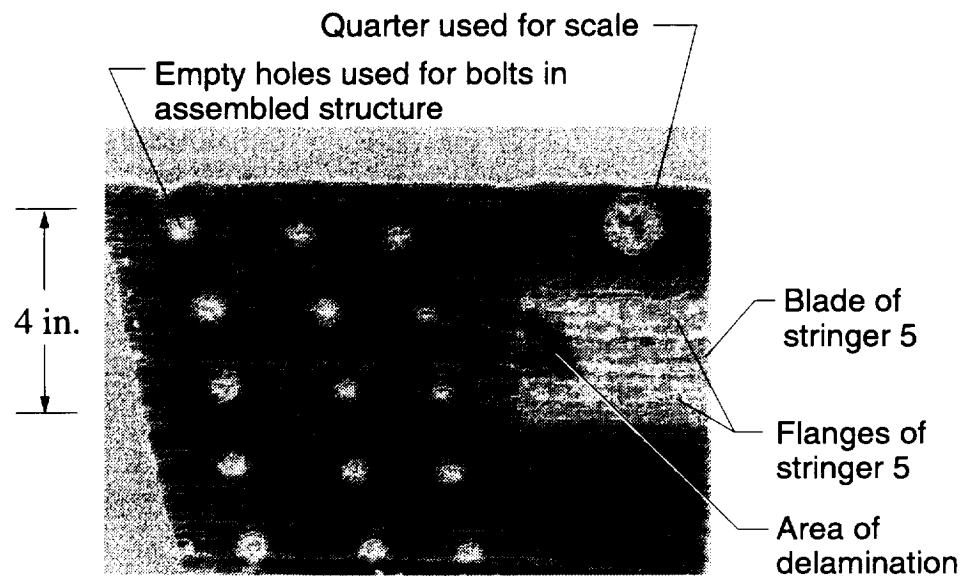
Figure 43. Damage area for upper cover splice on stringer 5.

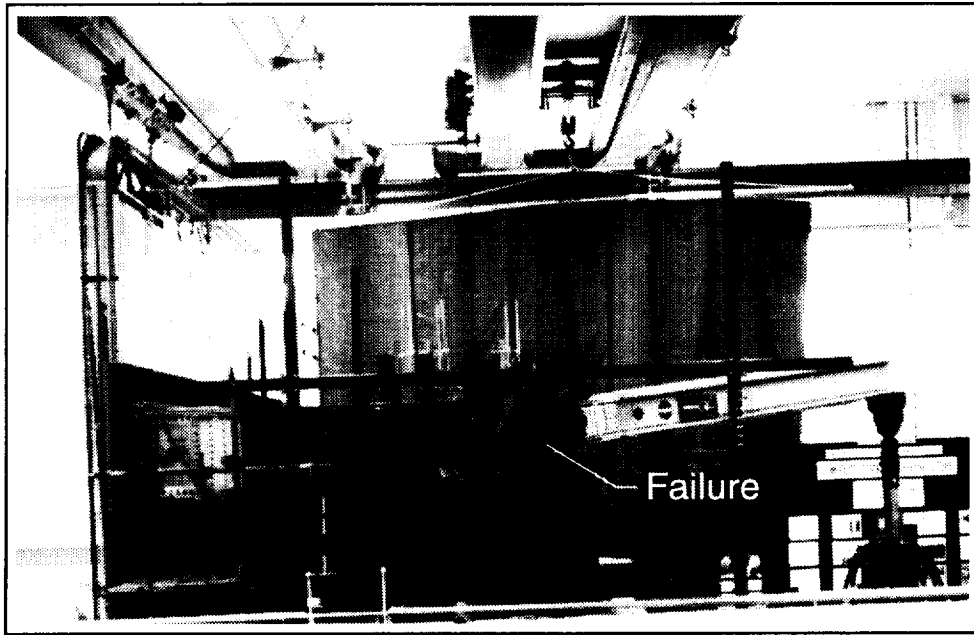
The maximum load supported by the structure at failure was 154 kips. A view of the entire structure after failure is shown in figure 63. Failure occurred across the entire width of the upper cover panel and into both spars. The lower cover panel skin remained intact. Photographs of the failures in the upper cover panel, and in the stringers between ribs 7 and 8 are shown in figures 64 and 65, respectively. Two independent failures occurred in the wing stub box. The first failure was in the unsupported region at the runout of stringer 6 where it terminates at rib 7 at a load of approximately 140 kips. During the test, the flanges and web of the stringer failed and the skin remained intact. This stringer has extensive damage in the form of delaminations between the skin and flange, broken stitches, bolts pulled through the flange, and cracking of the blade, as shown in figure 65b. The second failure was catastrophic and initiated at the nondetectable impact damage site at the runout of stringer 7. This failure began at a load of approximately 145 kips. This failure resulted in a crack that runs across the upper cover panel through impact damage site NDT2, as shown in figure 66, and across the upper cover panel into the spars. Failed stringers aft of the impact site are shown in figure 65a.

Figure 63. Side view of test specimen after failure.

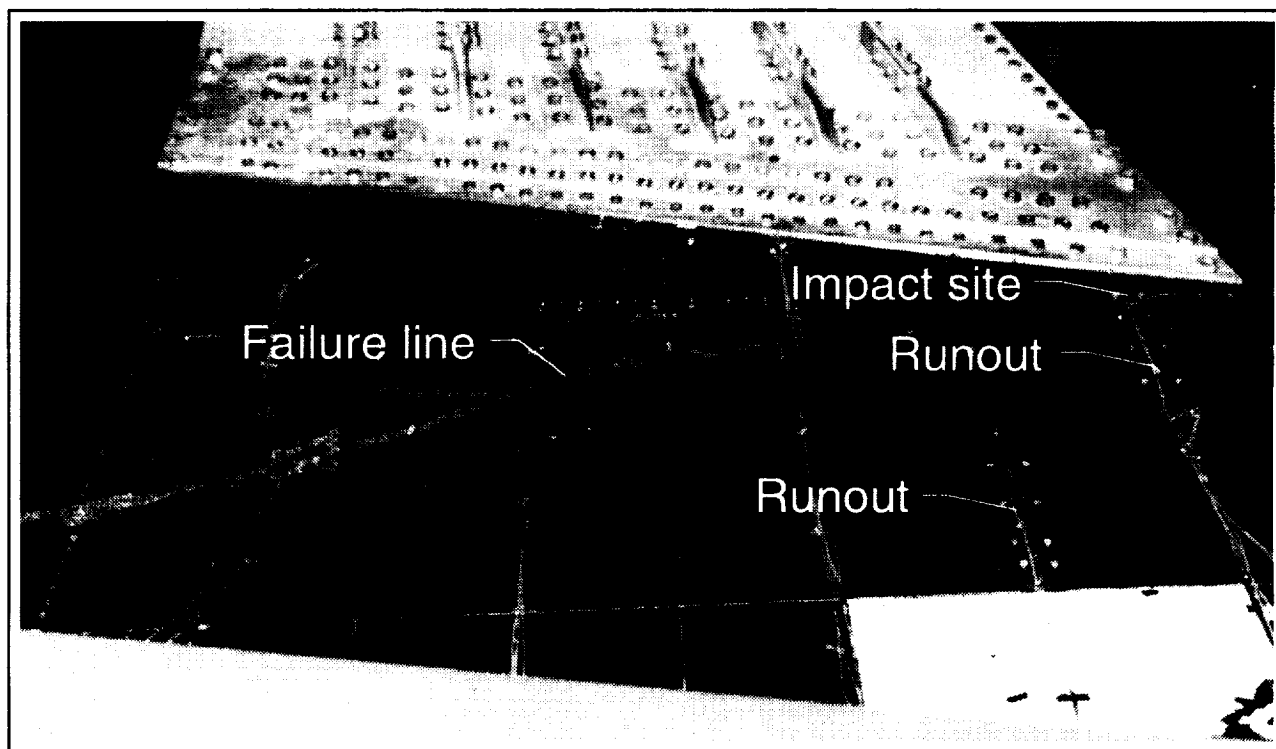
Figure 64. Upper cover after failure of test specimen.

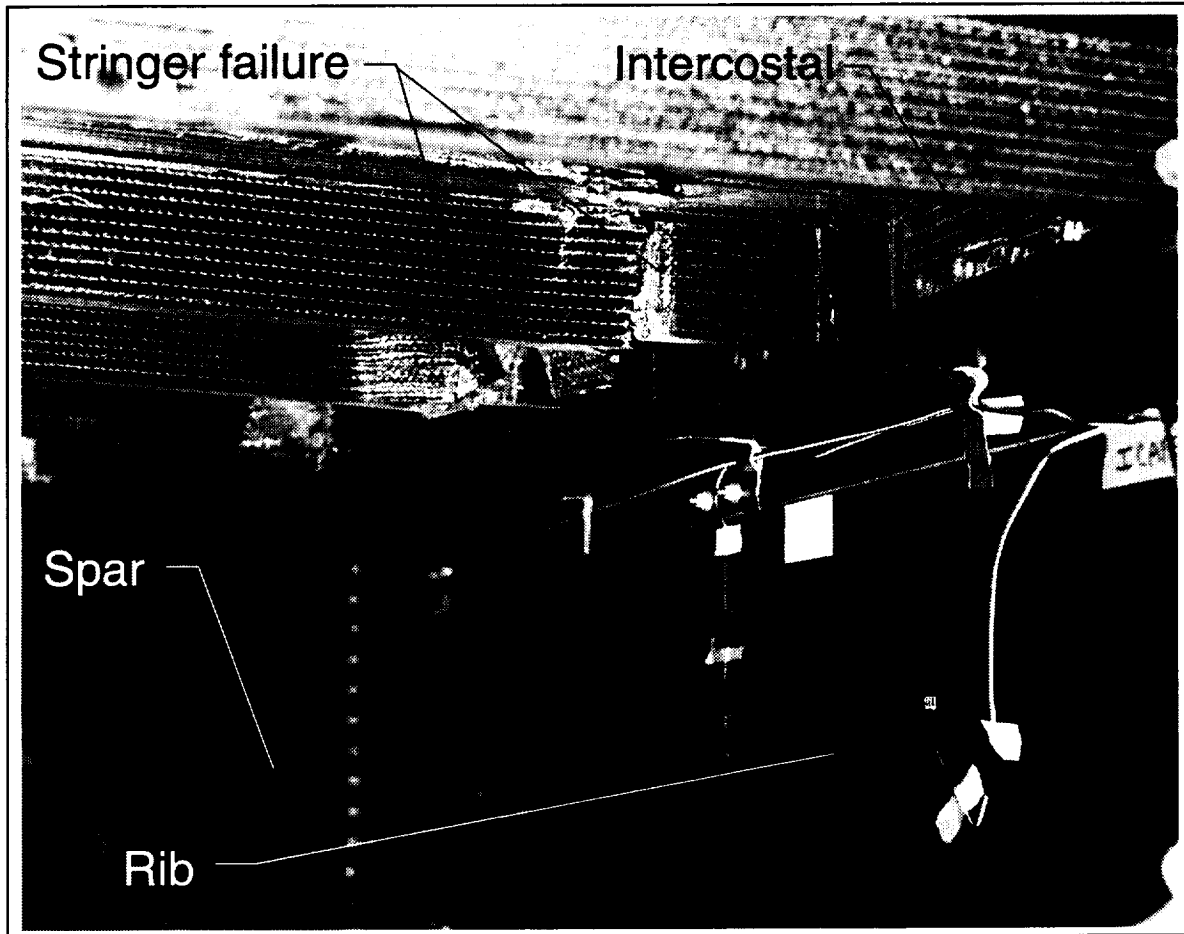
a) Failed stiffeners in upper cover panel

Delamination between the flange of stringer 5 and the upper cover panel skin inboard and outboard of rib 7 were also found, although the stitches between the flange and skin remained largely intact. Stringer 5 is on one edge of the unsupported skin region. This type of damage was not found in stringer 7, which is on the other edge of the unsupported skin region.

Figure 65. Failed upper cover panel stiffeners.

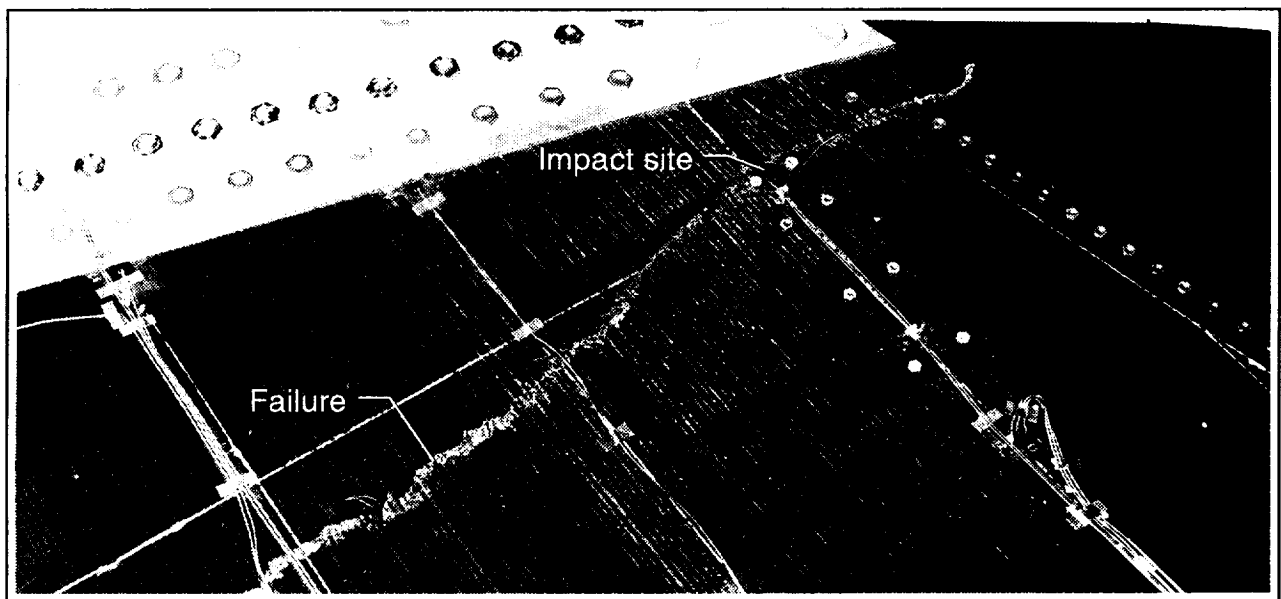
Figure 66. Failure through impact damage site NDT2.
